VULNERABILITY ANALYSIS OF TRADITIONAL HOUSING
IN DOMINICA

Frederick C. Cuny

INTERTECT
P.O. Box 10502
Dallas, Texas 75207

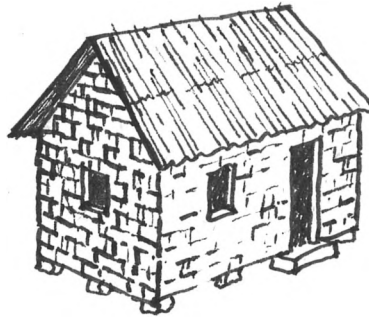
1. Wood Frame House

This type of house was rather severely damaged in the hurricane. Typical damage included the loss of the roof due to uplift on the eaves and lack of sufficient nails to fasten the galvanized sheets to the roof frame, and damage caused by the wind lifting the structure off the ground and pushing it into another object, or in some cases actually rolling the building.

The weak points of this type of structure include the connection between the roof frame and the walls, and the lack of proper anchoring of the structure to the ground.

- A. Changing the roof configuration from a gable to a hip roof.
- B. Using a truss to support the roof, and anchoring the truss securely to the walls by means of metal straps.
- C. Anchoring the house to the ground through the use of corner posts which are sunk into the ground and placing a rock or concrete block foundation around the structure at the base, so that the wind cannot

come up under the house.

If the above recommendations are followed, the structural performance of the building will be improved by approximately 25%, and the building should offer moderate to good protection during high winds.

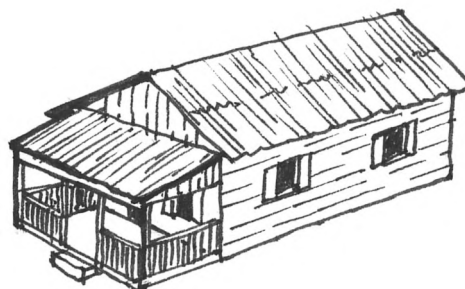
2. Wood Frame Housing, Urban Style

This type of house suffered relatively little damage during Hurricane David. The most typical type of damage was the loss of the roofing material and damage to the porch. Otherwise, the structures tended to remain intact.

The weak points of the houses are the connection between the porch and the

main structure of the building, the connection between the roof structure and the walls of the house, and the fastenings of the galvanized roofing materials to the roof frame.

The only recommended modification to improve structural performance during high winds is to reconfigure the roof from a gable roof to a hip roof configuration. Additionally, roofs should not extend more than 18" beyond the side of the wall, and the area beneath the overhang should be closed with an eave to reduce uplift on the edges of the roof. The posts that are in the ground should, of course, be treated to prevent deterioration.

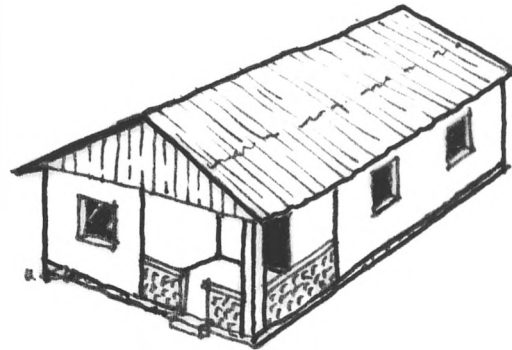
3. Single-story Concrete Block House

During Hurricane David, almost all of the concrete block houses in the country lost their roofs. This is due to a weak connection between the truss system and the ring beam. Furthermore, most of the houses built in this manner have relatively flat roof pitches and fairly large overhangs.

The configuration shown in the drawing is very popular. Unfortunately, the porch provides an excellent place for the wind to come up under the roof and lift the roof off the building.

Other weak points of the house include louvered windows which allow excessive amounts of air to enter the structure, creating positive pressure inside the house which pushes outward on the walls and upward on the roof.

- A. Changing the roof configuration from a gable to a hip roof.
- B. Developing a better connection between the roof truss and the upper ring beam of the house.
- C. Shuttering all louvered windows.
- D. Using a full porch instead of a quarter porch, and designing it in such a way that the porch can separate from the house in a wind storm without doing structural damage.
- E. Placing sufficient columns and ring beams in the walls to provide additional strength against the gust effects of high winds. Columns should be a maximum of $2\frac{1}{2}$ yards apart.
- F. Keeping overhangs to a maximum of 18". Build an eave under the overhang to prevent excessive amounts of air from being trapped under the overhang and contributing to roof uplift.

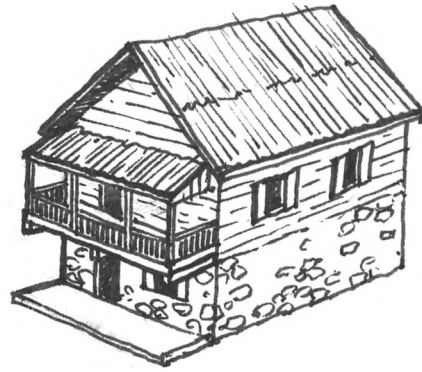
4. Two-story Wood Frame House on Rock
or Block First Story

This type of structure surprisingly weathered Hurricane David fairly well. The most typical damage was loss of roofing material and displacement caused by high winds pushing against the wooden structure and separating it at the joint between the upper building and the rock or block lower building.

The earthquake resistance of a structure such as this is not particularly good. These structures are both high and narrow, and the high center of gravity makes it difficult to stabilize the house during the violent shaking caused by an earthquake. However, because the upper story is made of wood, the weight decreases as the building increases in height. If sufficient strength is added to the lower walls through adequate reinforcement using columns and ring beams, if the foundation is well made and the building anchored securely to the foundation, and if the wooden upper part of the building is securely fastened to the lower portion of the house, then this type of building could conceivably survive an earthquake of moderate magnitude.

- A. Using adequate reinforcing in the lower story, to prevent collapse of the lower story and to help distribute both the weight of the structure and any forces which might act on the sides.
- B. Improving the connection between the upper and lower stories. This can be done by building a reinforced concrete ring beam at the top of the lower wall and placing numerous anchors where the wood frame is

attached to the lower story, and by developing a column system that extends to the upper story to give additional support to the walls.

- C. Using sufficient diagonal bracing at the corners to prevent distortion of the house during high wind loads on the upper portion of the building.
- D. Following the recommendations made for wooden structures regarding the roof.

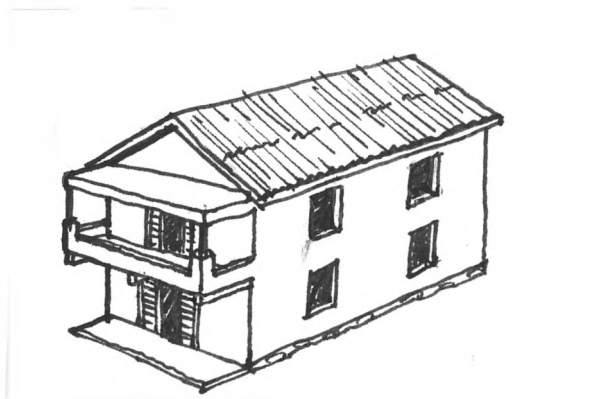
5. Two-story Concrete Block House

This type of structure generally fared well during Hurricane David, suffering only minor damage caused by loss of the roofing material. Most of these houses are built with some form of engineering or architectural input into the design.

The only modifications to this type of structure which would increase the performance of the building, or its safety, would be the detailing of the roof and roof overhang. The cantilevered porch should, likewise, receive special attention to make sure that it does not break off in a wind storm or earthquake, sealing off the door.
